WINSLOW-LINDBERGH REGIONAL AIRPORT Winslow, Arizona

AIRPORT MASTER PLAN - 1998 INTRODUCTION, BACKGROUND & INVENTORY

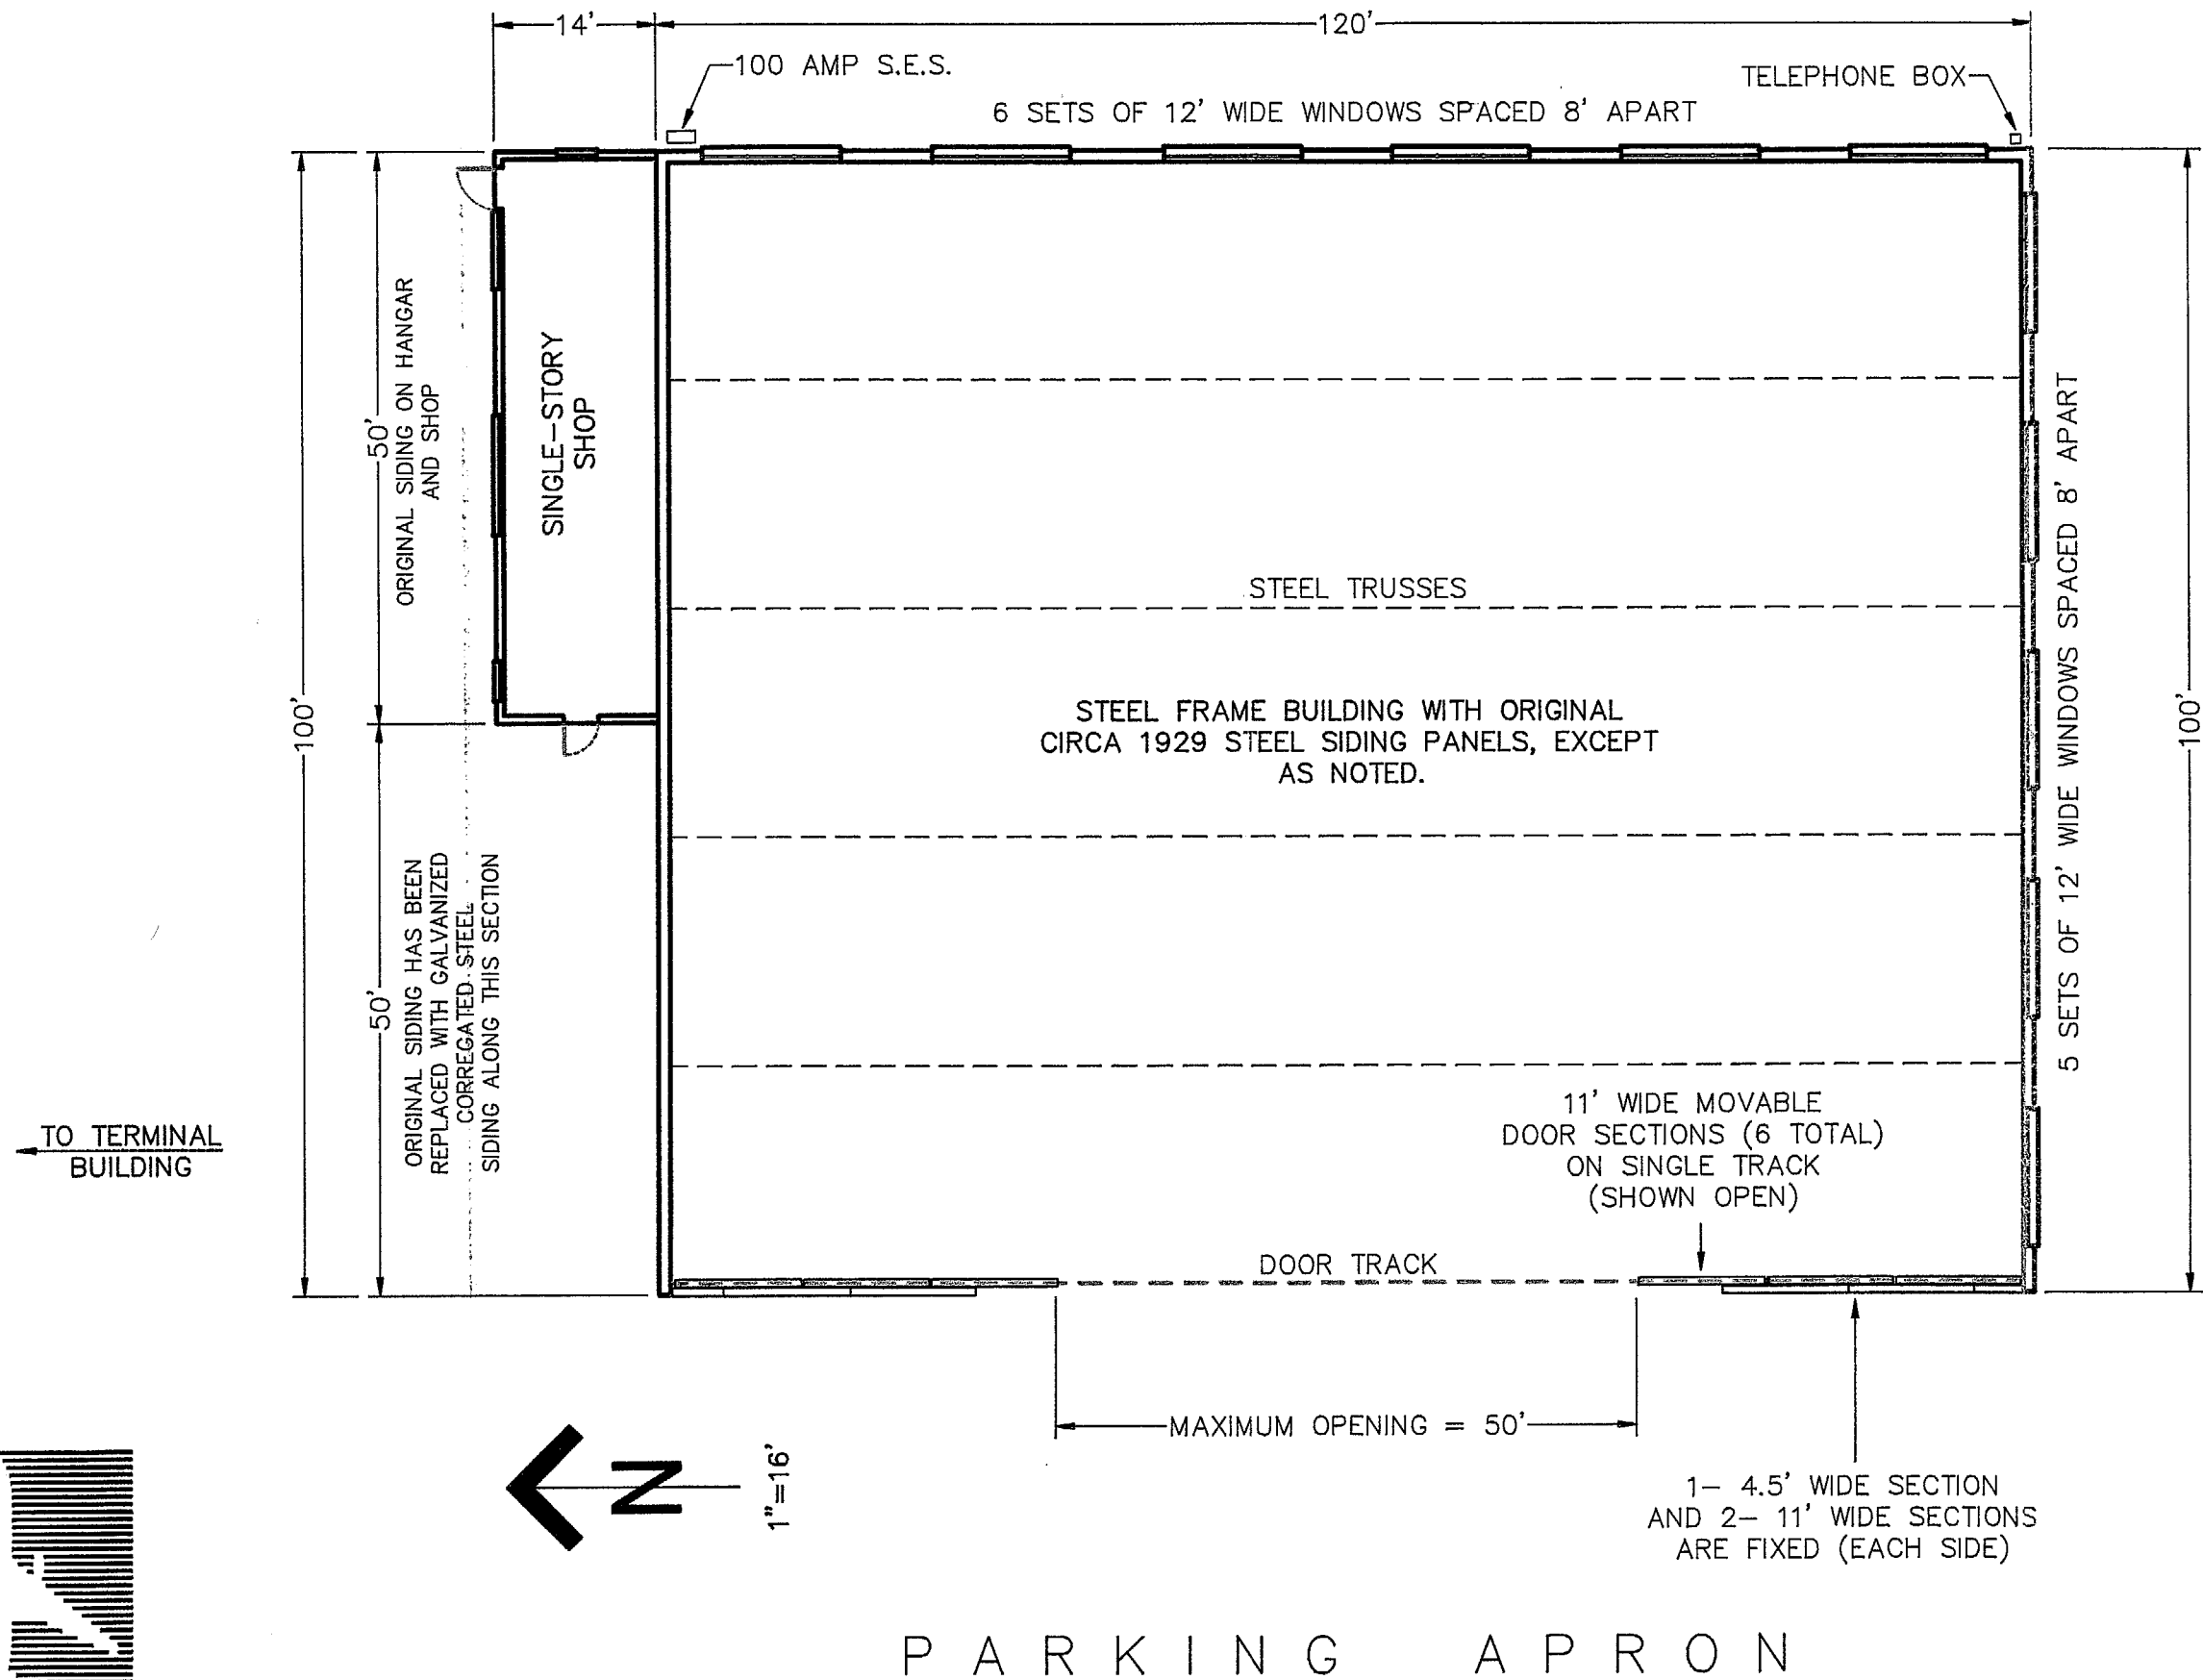
Winslow-Lindbergh Regional Airport Master Plan 1998
1929 T.A.T. HANGAR FLOOR PLAN

A treated wood foundation plate was used to support the metal wall panels and intermediate wall framing at both the hangar and shop areas. The plate at the hangar has a wolmanizing surface. The wood plate at the shop does not, and may be redwood. The plates are in need of replacement, and have pulled away from the foundation in areas. The plate at the shop area shows signs of deterioration from moisture entrapment.

The metal siding panels are in fair shape, and are unique in design. The availability for replacement will require custom manufacturing if the original design is to be preserved. The siding on about one-half of the north wall of the hangar has been replaced with corrugated steel siding, the result of storm damage.

The floor is of concrete slab on grade construction. The condition is poor.

The roof is metal standing seam panels with evidence of leaking. The roofing membrane at the shop area is a built-up bitumen with a mineral surface cap sheet in fair condition, but with evidence of an unstable substrate. Plywood is exposed at the eaves in some locations.

1. Determine the feasibility of Historic preservation.
2. Replace the metal siding panels as needed with panels manufactured to match the existing design. Replace the existing foundation plate with corrosive resistant steel.
3. Reroof the barrel vaulted hangar portion. Provide core samples at the shop area to ascertain the condition and assembly of the substrate. Reroof the shop area per specifications based upon the core sample test results.
4. Remove and replace, or over-pour the existing concrete floor slab.
5. Rebuild the existing hangar door as needed.
6. Paint the hangar exterior and make repairs to windows as needed.

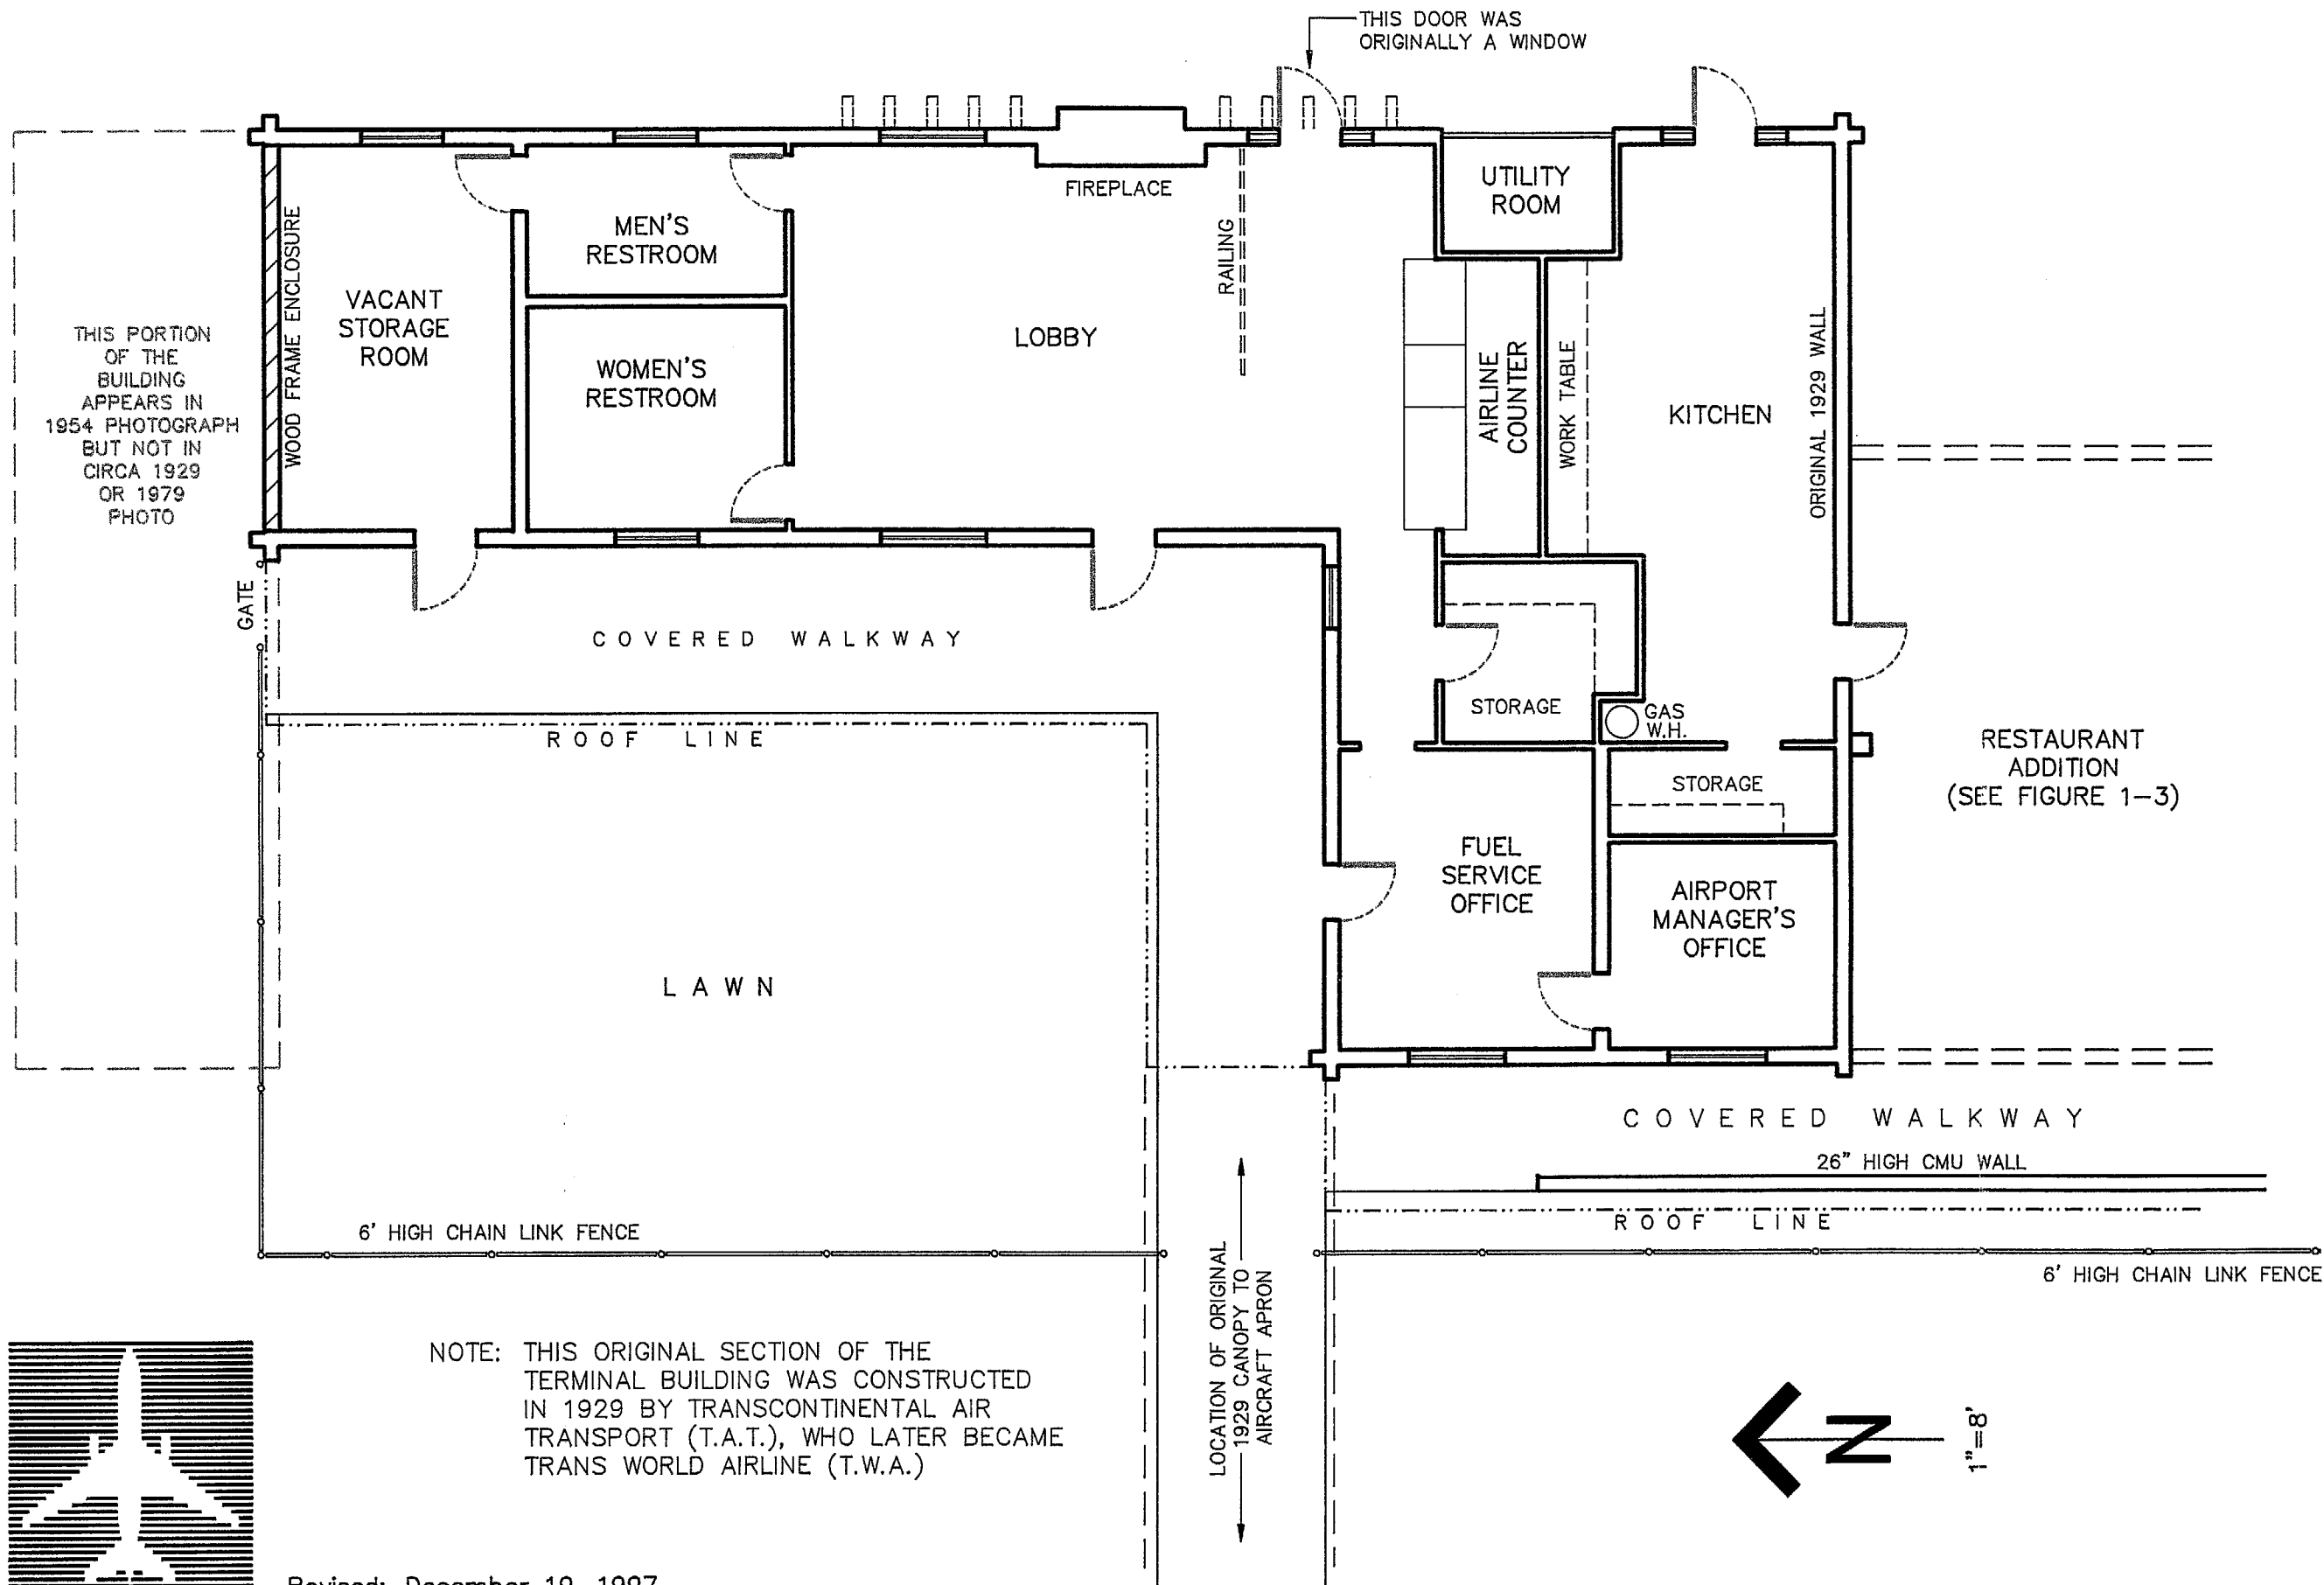
Winslow-Lindbergh Regional Airport Master Plan 1998
1929 T.A.T. TERMINAL - ORIGINAL SECTION

however no evidence of adobe construction was observed during the inspection. Inspections were made of the exterior wall assemblies where possible, without core drilling, at places where the stucco finish had separated, where cracks were visible, or where the assemblies were visible from deterioration. In all cases common brick construction was observed at exterior parapets, the two chimney stacks, and at door and window jambs. This inspection does not rule out the existence of adobe construction. It is possible that the exposed and deteriorating portions of the structure only, are of brick construction (chimneys, parapets, and jambs). Or inferior repairs or modifications could have been made to the structure using alternative materials and resulting in accelerated degeneration at these locations. Core samples are recommended to determine the material content prior to any structural remodeling or renovations. If this structure is to be designated as a Historical building, the existence of adobe will have a significant impact on its acceptance as Historical. Without core samples the exterior wall assemblies are presumed to be of double or triple wall brick construction. The exterior finish is of approximately 1/2" cement plaster in a heavy skip trowel texture.

The roof membrane at the north (Terminal) building portion consists of built-up asphalt bitumen with an emulsion surfacing in poor condition. Scuppers were used at parapet penetrations, without adequate crickets. Evidence of leaks were observed at

1. Determine the feasibility of Historic preservation.
2. Restore and repair the existing exterior of the original structure. Remodel the exterior of the addition (the southern masonry portion) to harmonize with the

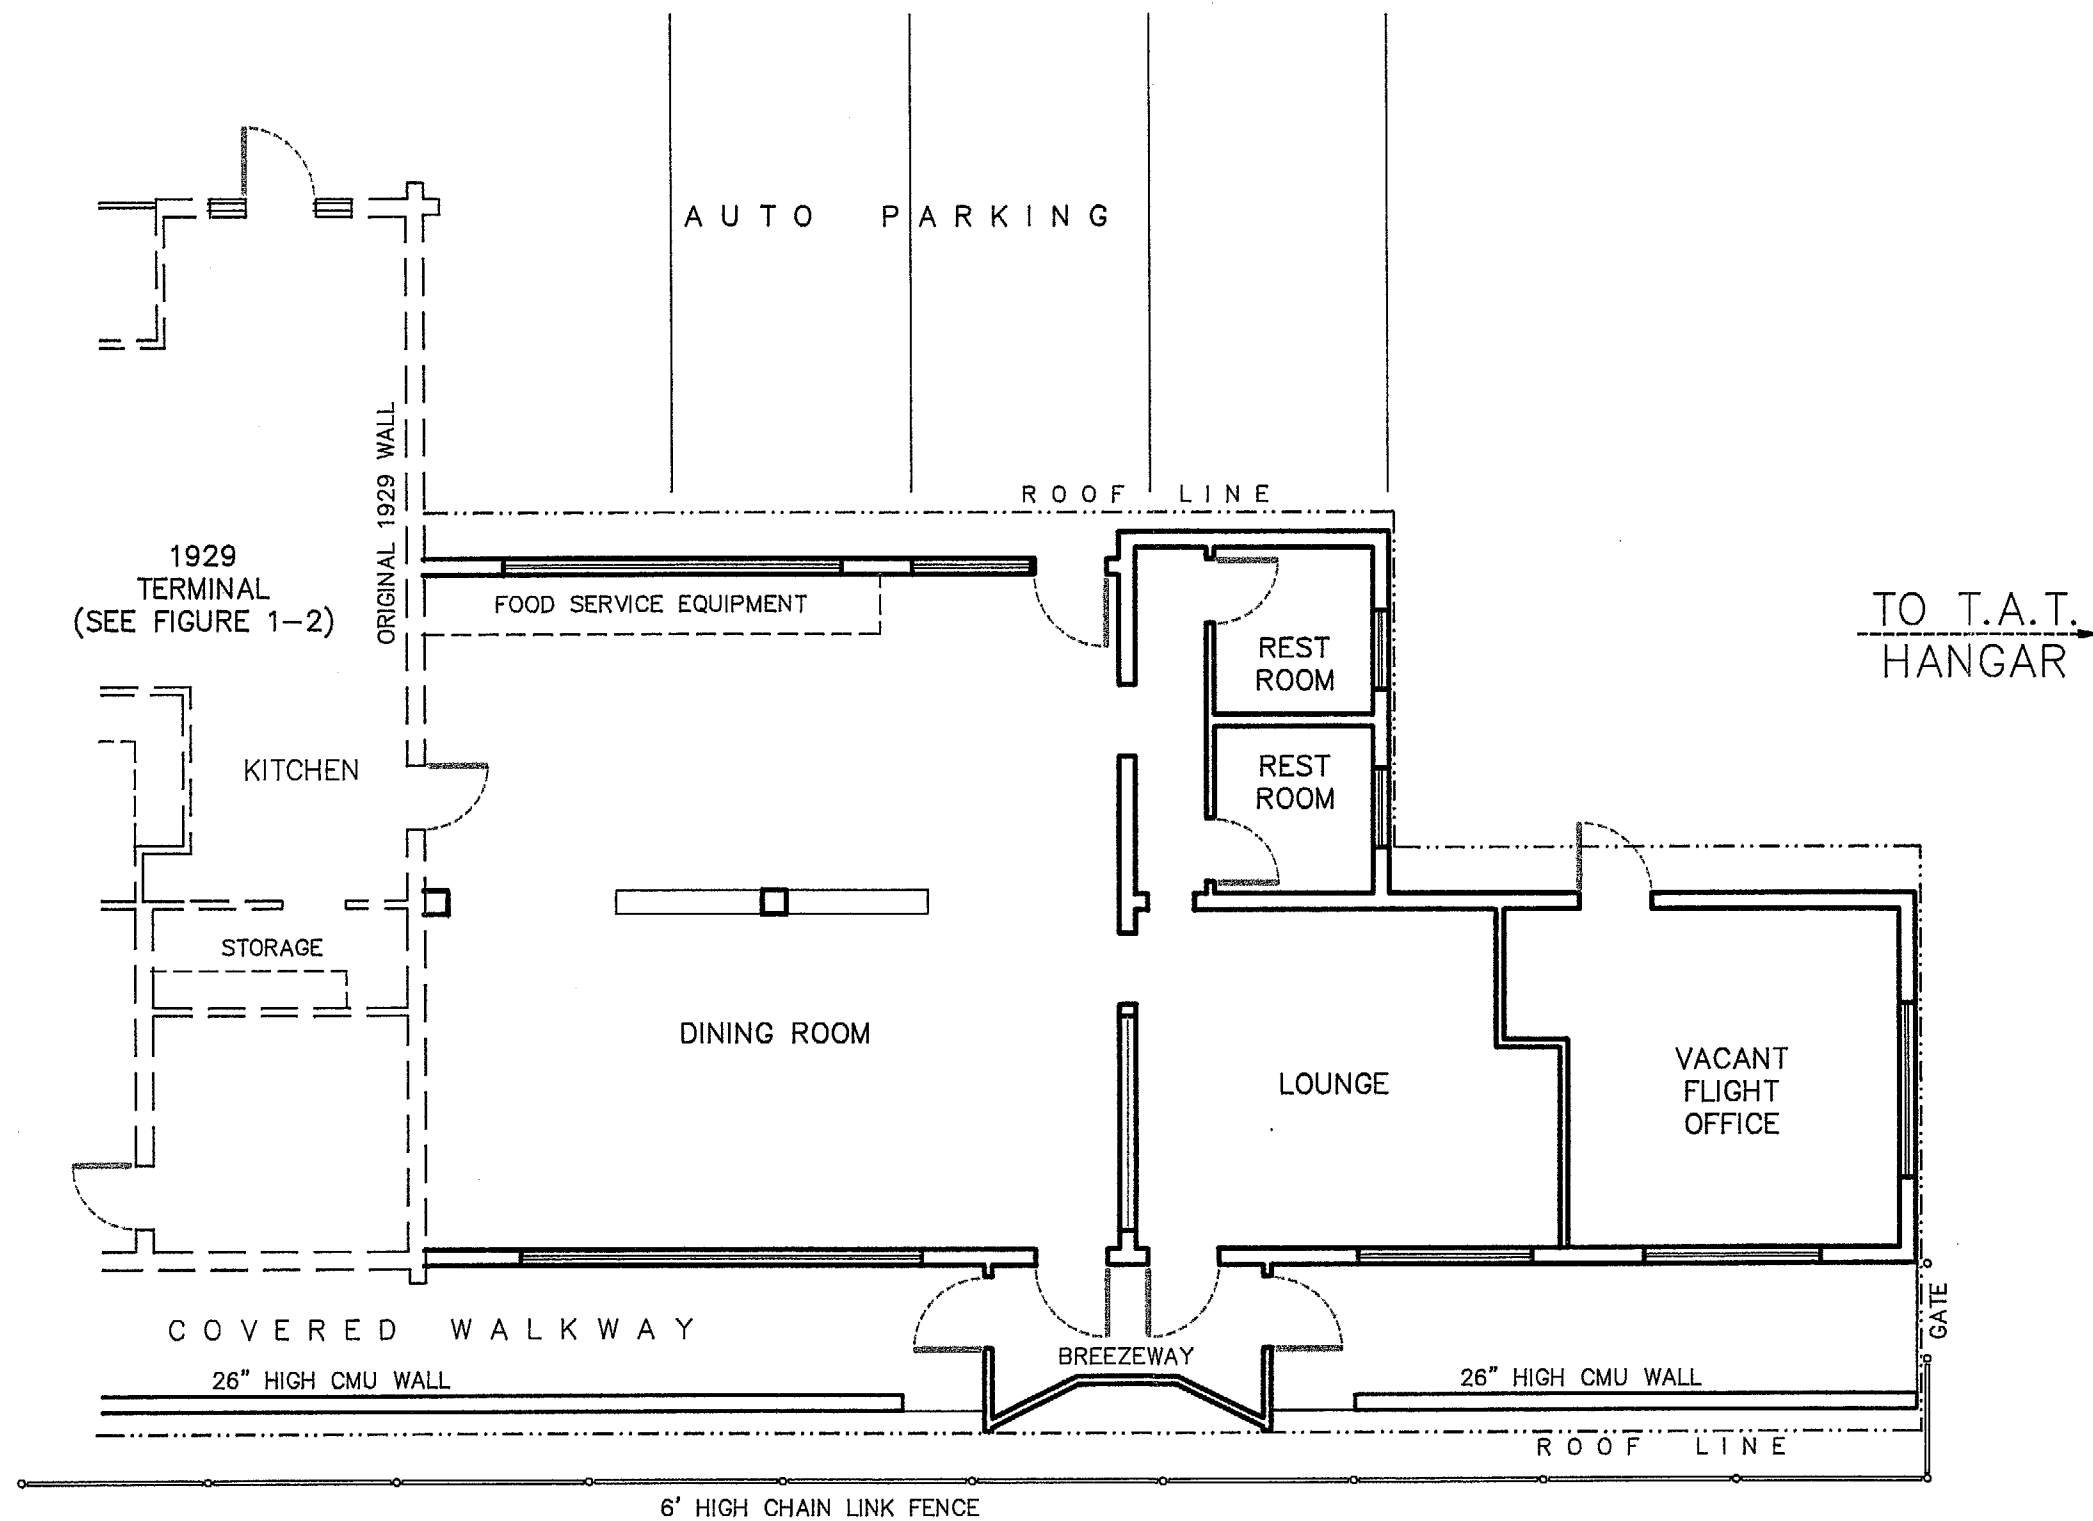
Winslow-Lindbergh Regional Airport Master Plan 1998
TERMINAL BUILDING - RESTAURANT ADDITION

Differential settlement was observed at the northwest section of the covered walkway. Indicating the absence of adequate post footings or unstable soil conditions.

The roof membrane at the restaurant addition consists of built-up asphalt bitumen with a mineral surface cap sheet in poor condition. Evidence of leaking was visible especially at the covered walkway. Roof slope is adequate.

Roofing core samples are recommended prior to any remodeling or renovation, to ascertain the condition of the substrate, and/or the presence of asbestos in the assembly.

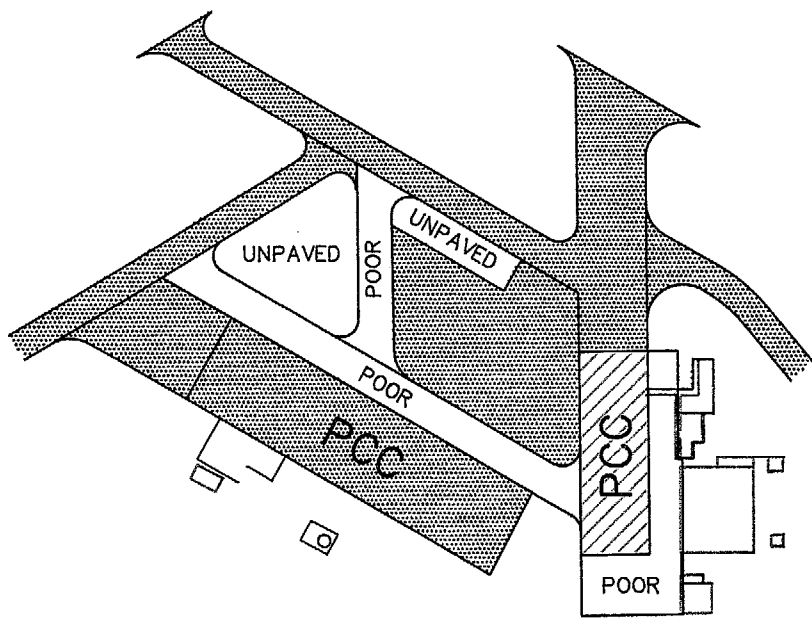
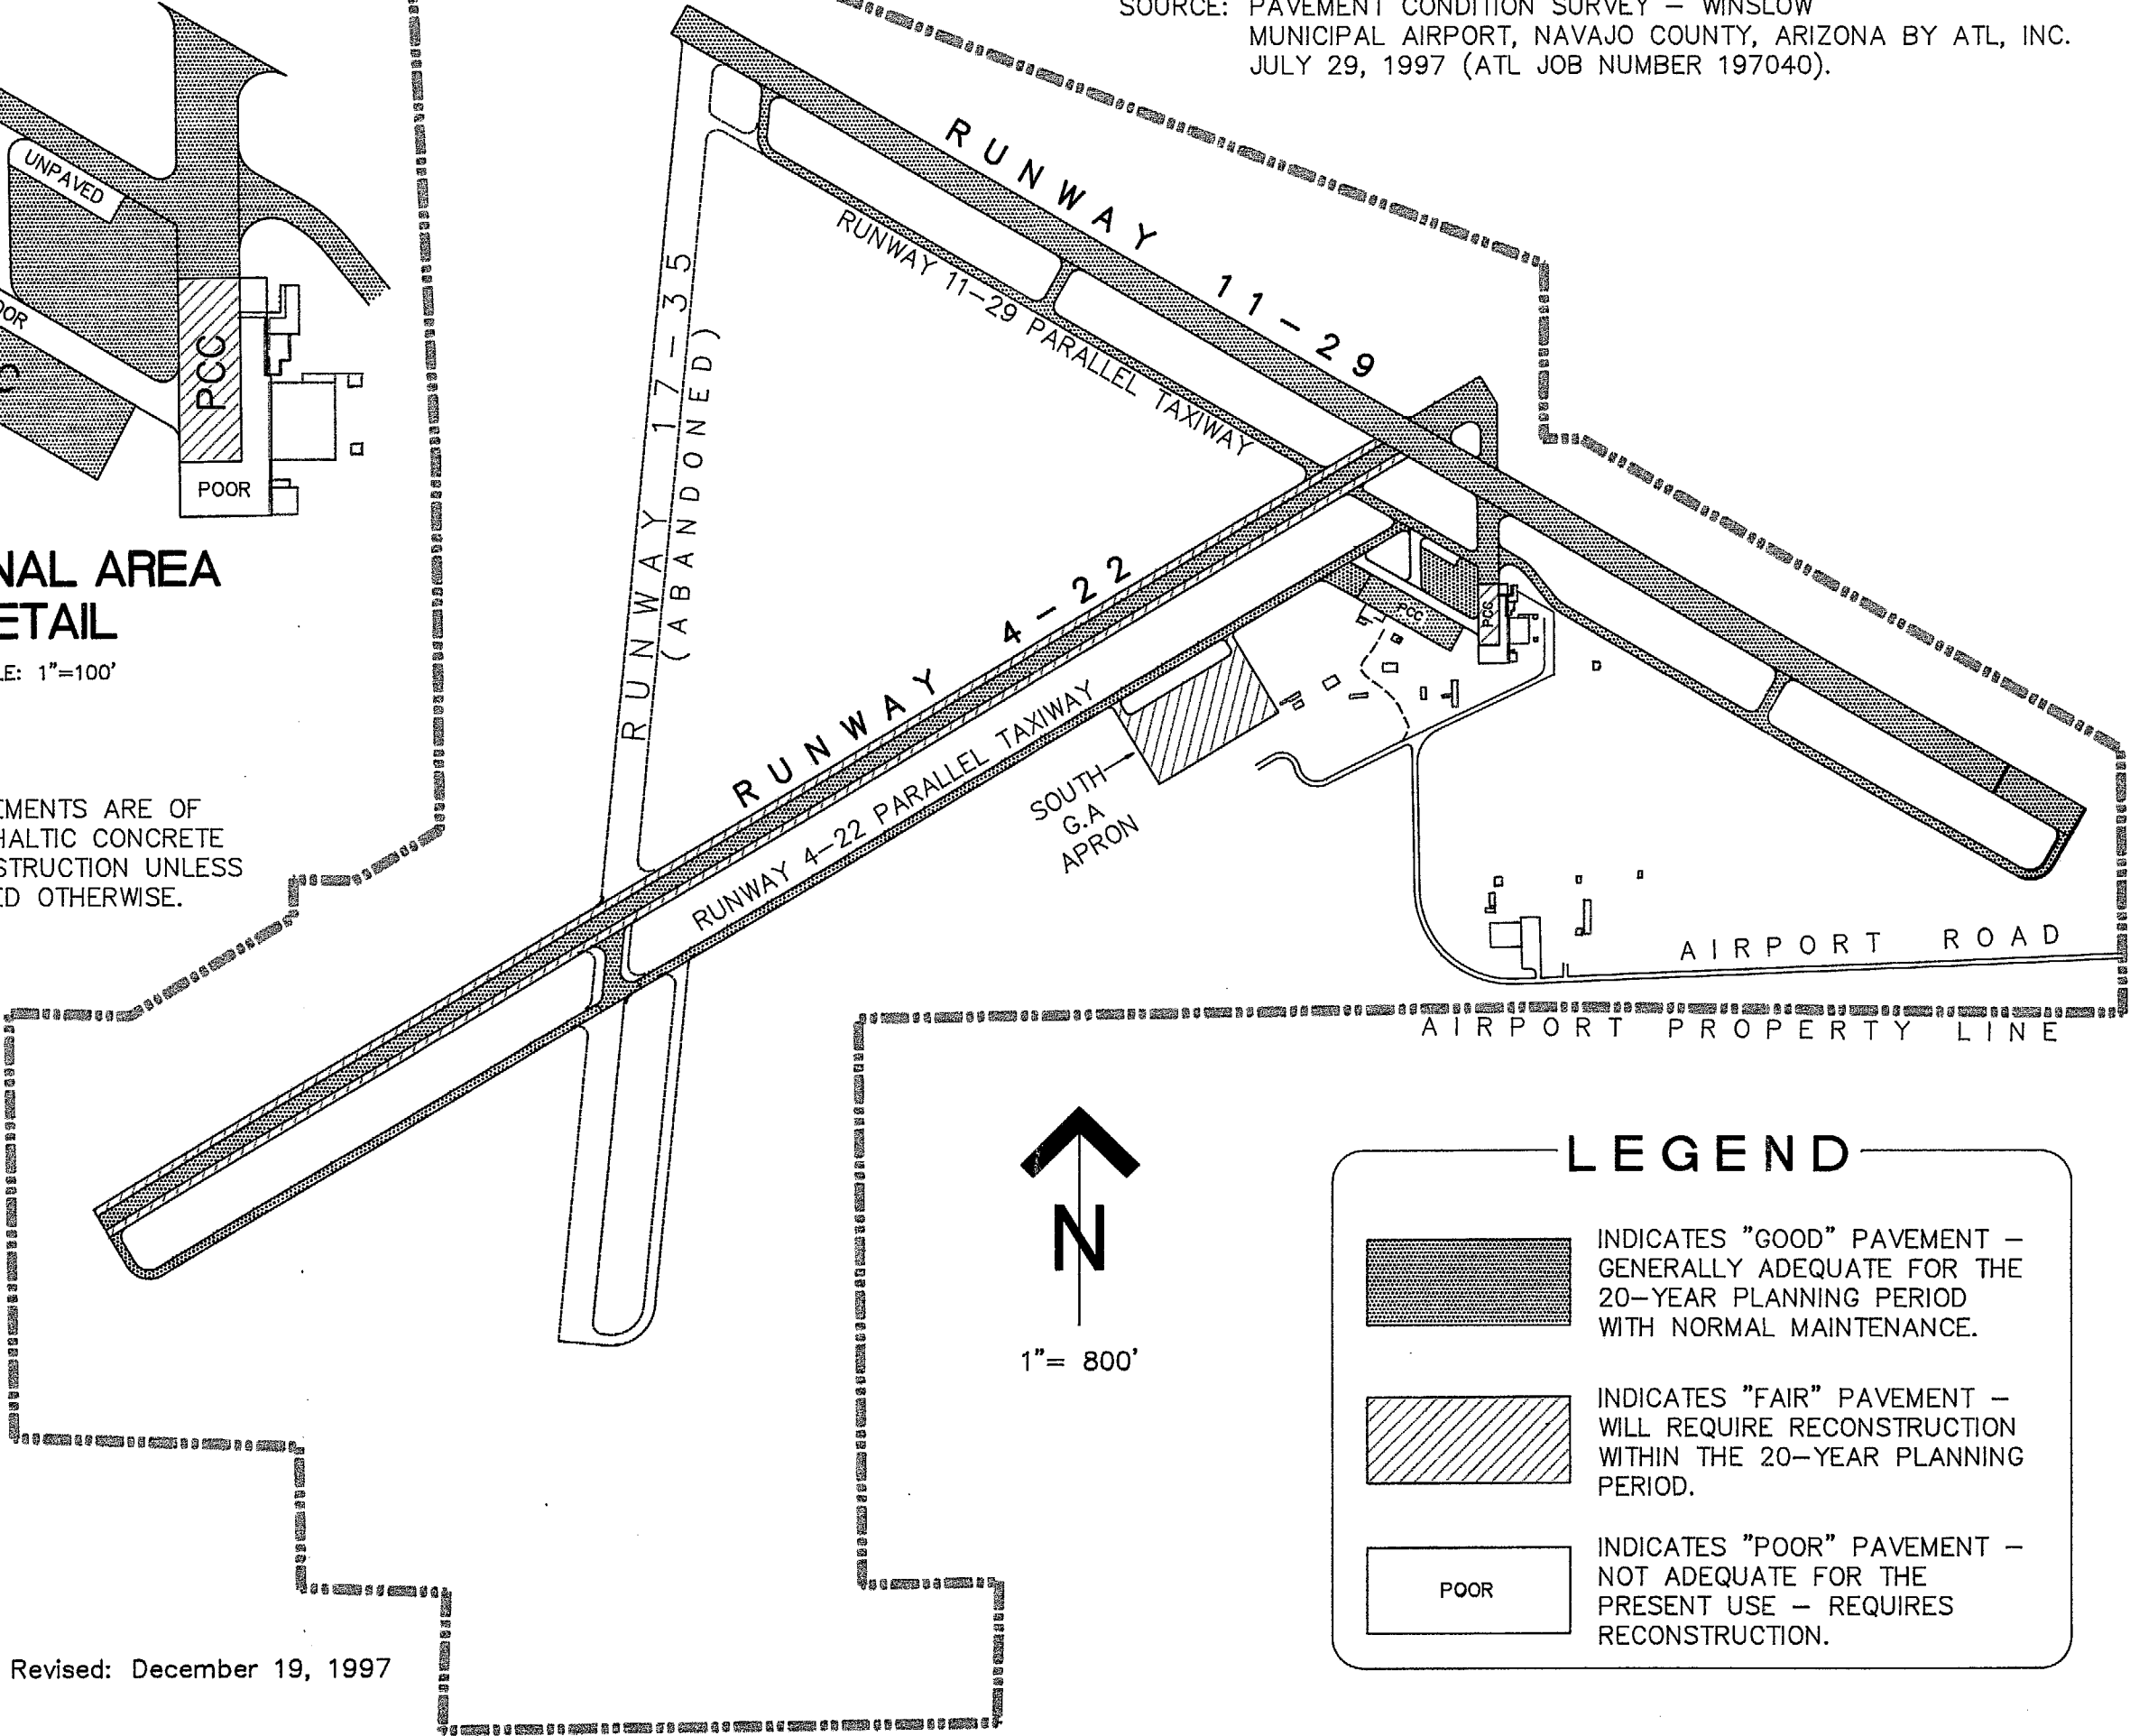
**TERMINAL AREA
DETAIL**

The condition of the various existing pavements is summarized on Figure 1-4, Airport Pavement Condition Index Map, at the end of this section.

Of the two PCC areas, one is approximately one year old and was rated in Good condition (the ATL report categorized this as "Excellent"), with an average PCI of 94.8. The other PCC apron is considerably older, possibly constructed when the airport Terminal Building was built in 1929. It was rated as Fair, with an average PCI of 41.5. Most slabs exhibit cracks across their full width with some corner breaks and spalling in evidence. The joints are filled with soil. Some joints are up to three inches wide. Considerable shoving of the adjoining asphaltic concrete pavements has occurred. The storm drain at the north end of the PCC area is approximately three inches higher than the pavement, causing ponding on the pavement.

The asphaltic concrete ramp area between the PCC sections and the TAT Hangar and Terminal Building are rated as Poor, with an average PCI of only 20 (the ATL report classes this area as "Very Poor"). This area exhibits many areas of cracking, raveling and shoving.

The remainder of the asphaltic concrete taxiways and parking apron connections in the terminal area are in Poor condition, with an average PCI of only 18. The taxiways within this area show considerable longitudinal, transverse and block cracking with bleeding covering from 20% to 50% of the surface area.

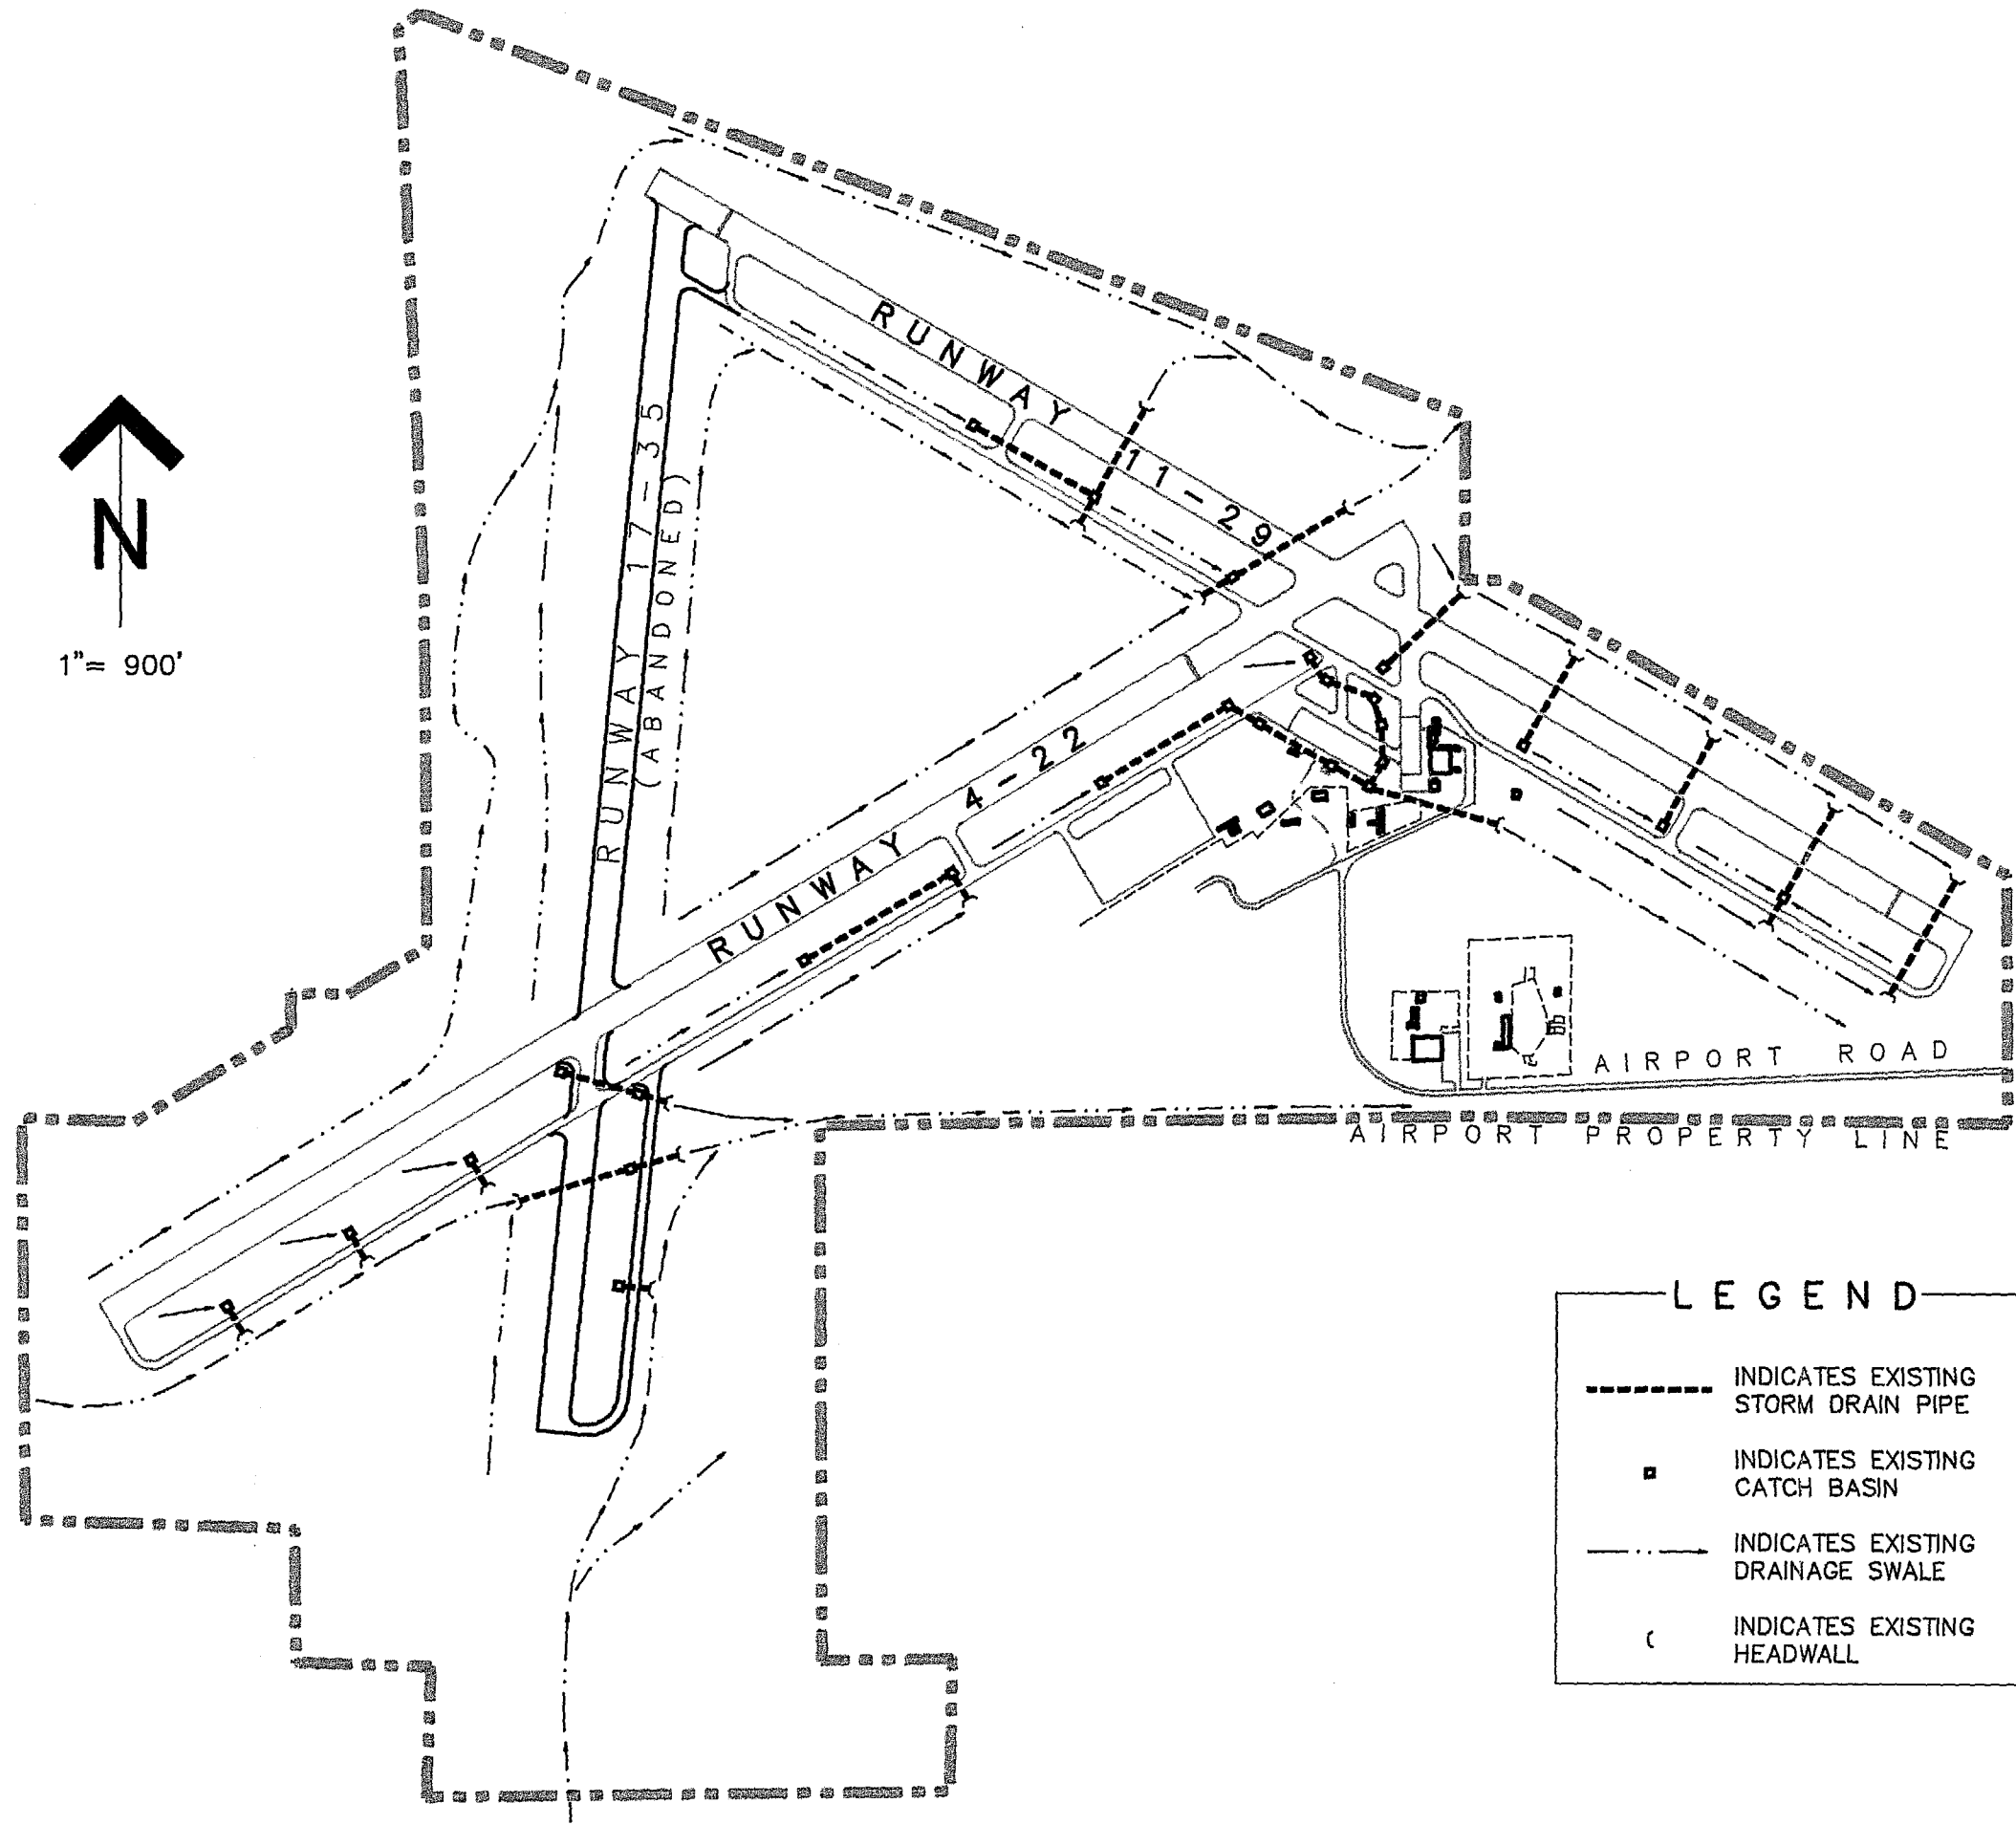
Winslow-Lindbergh Regional Airport Master Plan 1998
AIRPORT DRAINAGE MAP

A visual inspection of the existing airport storm drains and surface drainage features indicates that the system appears to be functional and in generally Good condition. Some of the catch basins in the terminal apron area do not appear to drain properly during periods of intense rain. These features may be undersized, or there may be underlying damage to connector pipes.
